ARMY RESEARCH LABORATORY

T-55 Engine Compressor Stator Vane Investigation

ARL-TR-2123

November 1999

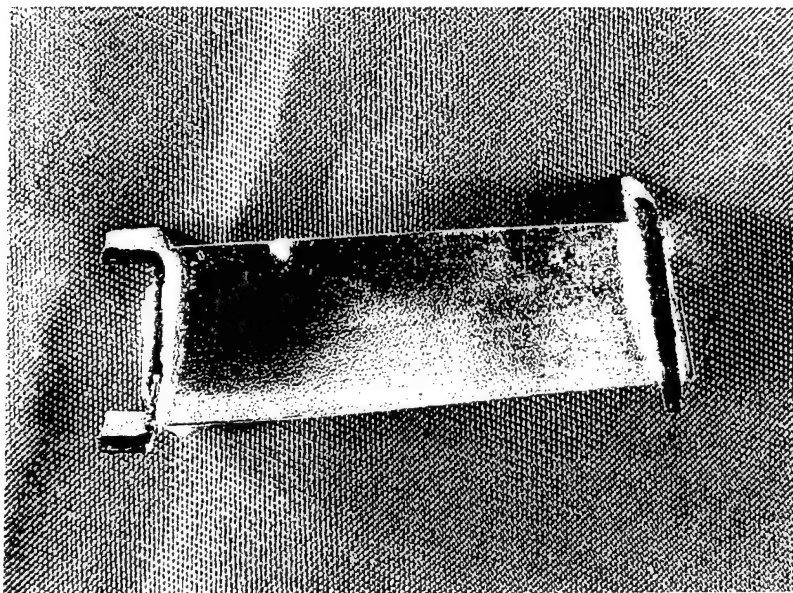
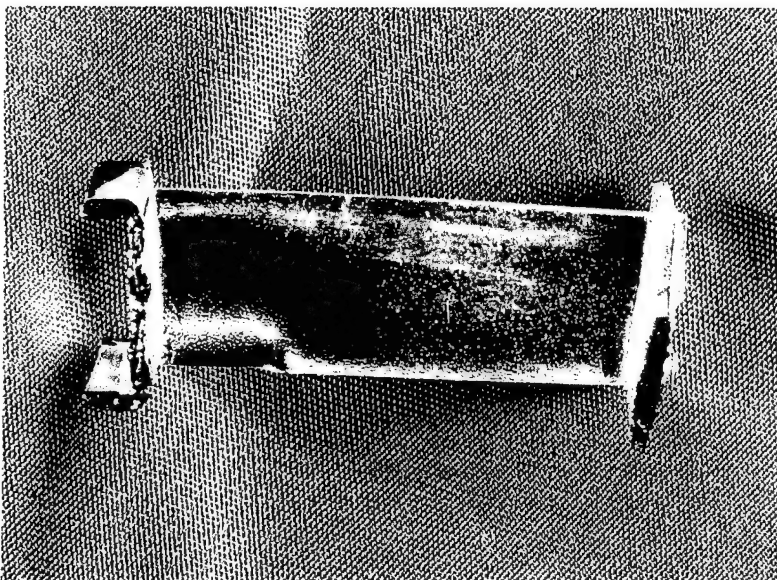
4.1 Corrosion Testing. The most recently received assembly was tested side by side against sections from the old component that had been chromic acid dipped (0.42% chromic acid, the minimum recommended by the manufacturer, and 2.33% chromic acid) according to the suggestions of MacDermid. Figures 20 and 21 depict a section of the new stator before salt fog testing. Figures 22 and 23 show the old component that had been dipped in 0.42% chromic acid for comparison. The extremely bright shiny cadmium coating on the new stator can be directly

Figure 20. New Section of the Stator Vane, Concave Side (Magnified 1.5×).

Figure 21. New Section of the Stator Vane, Convex Side (Magnified 1.5×).

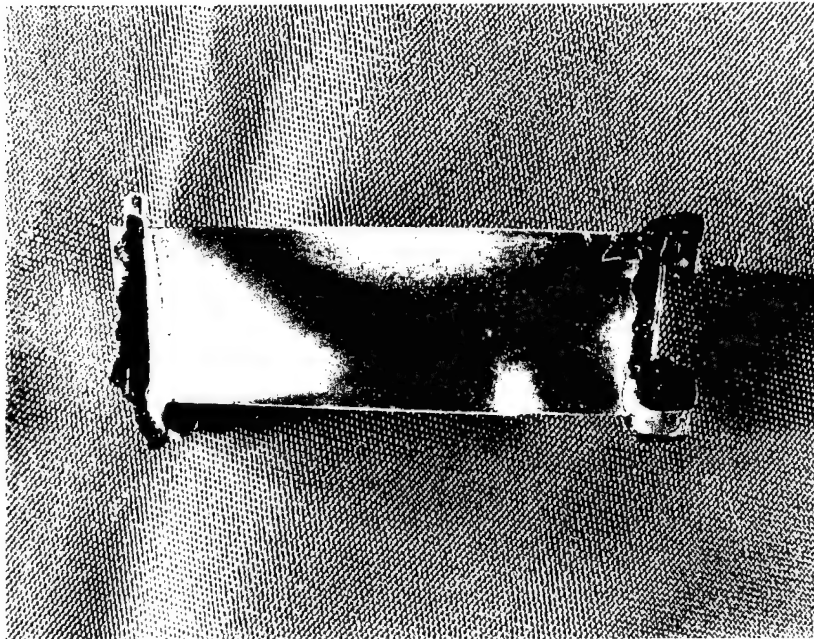
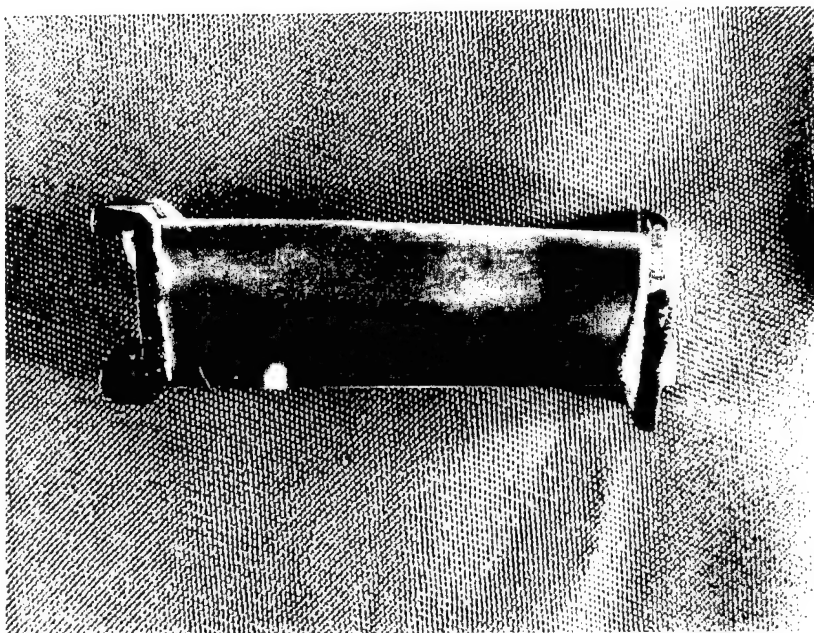
Figure 22. Previous 0.42% Dipped Stator, Concave Side (Magnified 1.5×).

Figure 23. Previous 0.42% Dipped Stator, Convex Side (Magnified 1.5×).

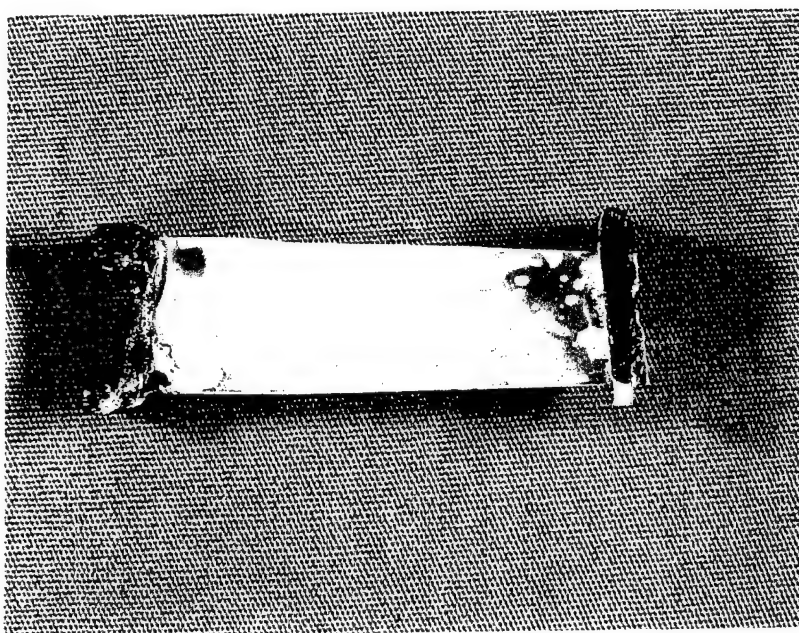
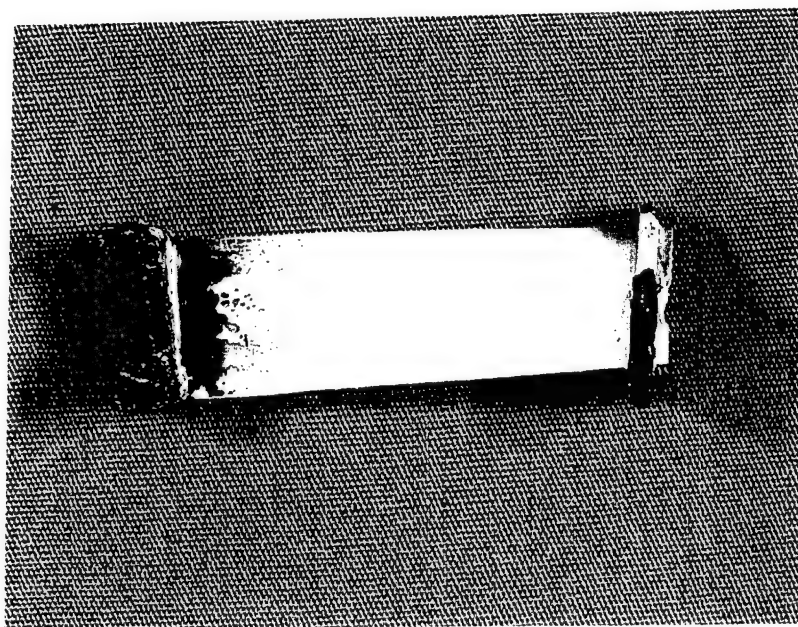
After 200 hr exposure per ASTM-B-117, the new stator exhibited significant white product along the vane and severe pitting within the braze area, as shown in Figures 36 and 37. Figures 38 and 39 depict the corrosive action on the 0.42% dipped old stator and general corrosion can be observed. This general corrosion was more representative of the previous results obtained. However, the area of corrosion seemed to be limited to the inner shroud braze area. Comparative macrographs of the new stator vs. the old 0.42% dipped stator are shown in Figures 40 and 41. After 200 hr of exposure, general corrosion of the 0.42% dipped stator was observable near the inner shroud brazed area and pitting was observable on the new corrosion system stator. It could not be determined which corrosion-resistant coating performed better. Neither would pass the corrosion requirements established in AMS 2400 Rev. S [2].

Figure 38. 0.42% Dipped Stator After 200 hr Salt Fog Exposure, Concave Side (Magnified 1.5×).

Figure 39. 0.42% Dipped Stator After 200 hr Salt Fog Exposure, Convex Side (Magnified 1.5×).

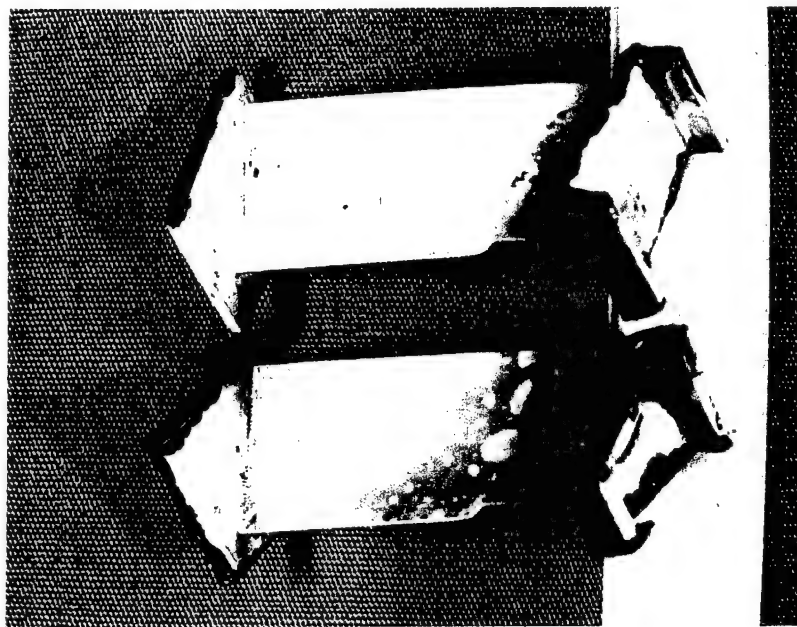
Figure 41. 0.42% Dipped and New Stator Sections After 200 hr Salt Fog Exposure, Concave Side, Braze Area (Magnified 1.5 \times).

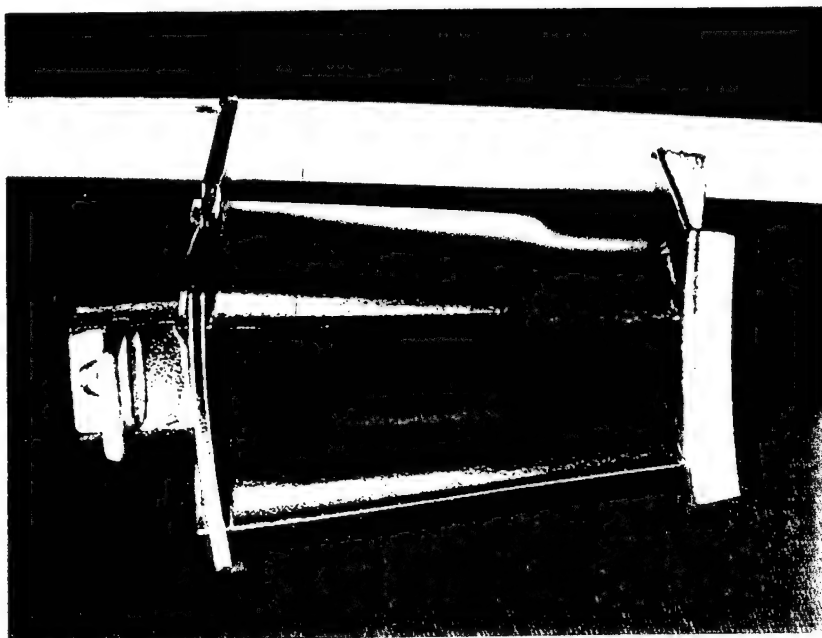
5.2 Corrosion Testing. The most recently received stator section was salt fog tested in accordance with ASTM-B-117. Figures 50 and 51 depict the concave and convex sides of the section before salt fog testing, respectively. Figures 52 and 53 show the inner shroud vane braze area with more clarity, also prior to salt fog exposure. The yellow iridescent hue of a chromium sealer is clearly evident.

Figure 50. Replated Section of the Stator Vane, Concave Side (Magnified 1.5×).

Figure 51. Replated Section of the Stator Vane, Convex Side (Magnified 1.5×).

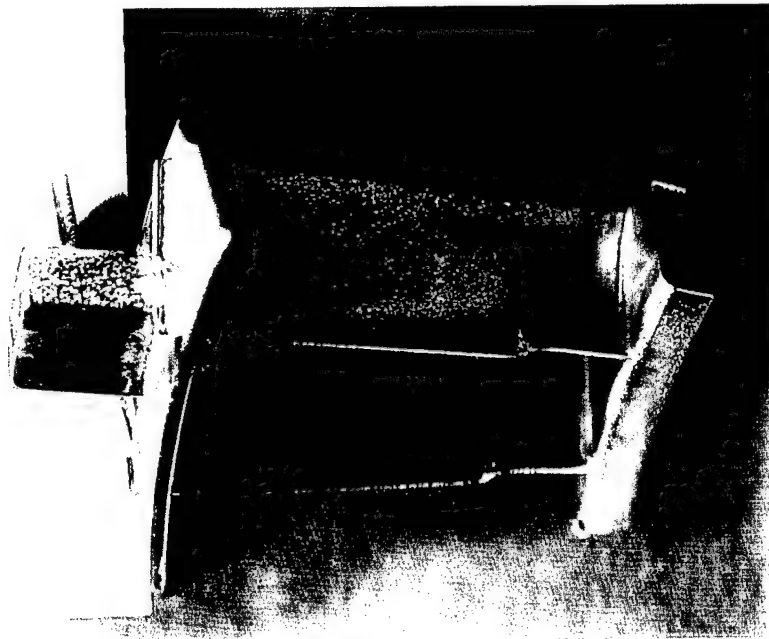
Figures 54–57 depict the stator section after 24 hr salt fog exposure (compare with Figures 50–53). The chromium sealer is still evident even after 24 hr of exposure. There was no white cadmium oxide product visible on the section.

Figure 56. 24 hr Salt Fog Exposure, Braze Area, Concave Side (Magnified 1.5×).

Figure 57. 24 hr Salt Fog Exposure, Braze Area, Convex Side (Magnified 1.5×).

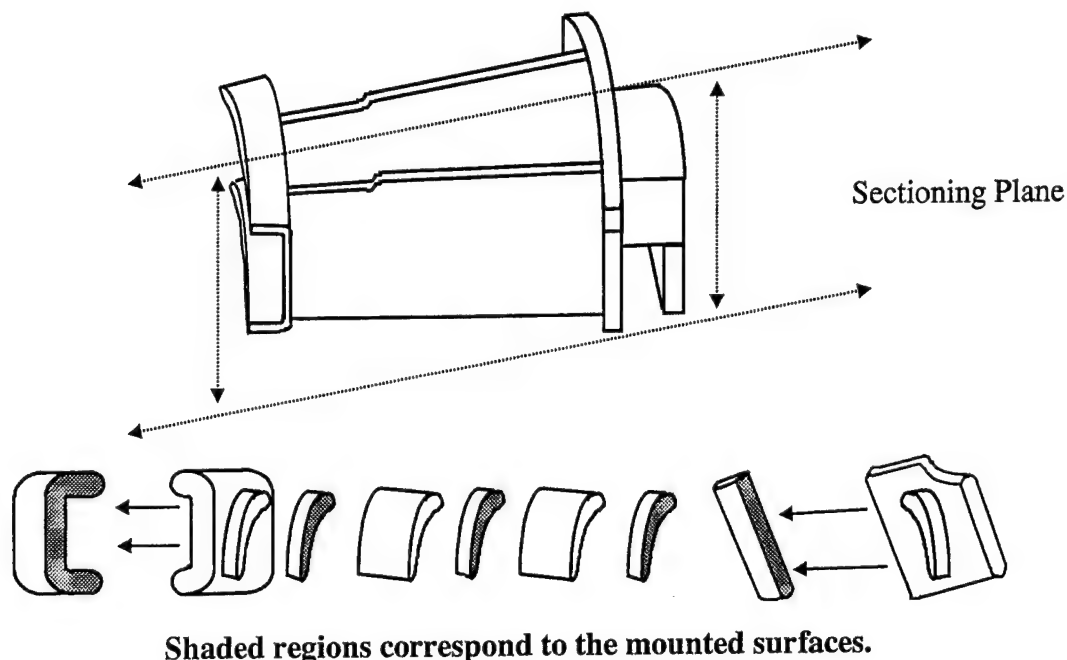
Figure 63. Diagram of Sectional Stator Vane.

5.3 Sectioning. The stator vane was sectioned after corrosion salt fog experiments to create several cross sections for cadmium coating thickness measurements. A sectioning diagram (Figure 63) is provided as follows:
